THE PARLIAMENT OF THE REPUBLIC OF FIJI

RESPONSE TO WRITTEN QUESTIONS

47/2021 Hon. Mitieli Bulanauca to ask the Minister for Infrastructure, Meteorological Services, Lands and Mineral Resources –

WORK PROGRAMME OF CYCLONE REHAB WORKS TO BE UNDERTAKEN

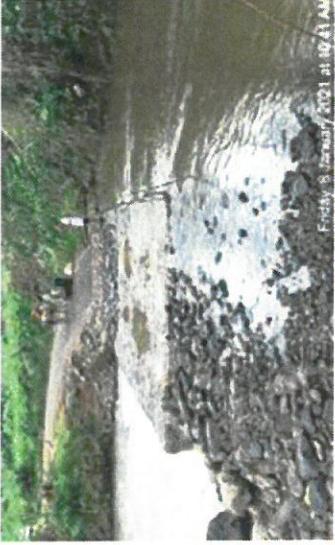
Road Name	Asset Type	Location (km)	Status of Damage/Recommendation	Photo	Cost	Construction Duration
Zone 1 - Labasa						
Nayarabale Road	Bridge – Low level Crossing Nayagalevu	11.037km	<p>Status: Approaches on both sides damaged and being continually washed out by flood waters. Deck rebar exposed. Backfill on abutment washed out. Condition of superstructure has surpassed its lifespan.</p> <p>Recommendation: Construct new crossing (12m)</p>

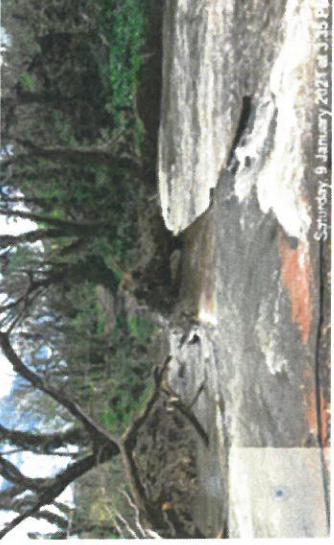
3 – 4 months	
Coqeloa Road	Bridge – Low Level Crossing Qeleimumu	8.416km	<p>Status: Approaches on both sides continually washed by flood waters.</p> <p>Recommendation: Extend approaches both ends to prevent washouts</p>

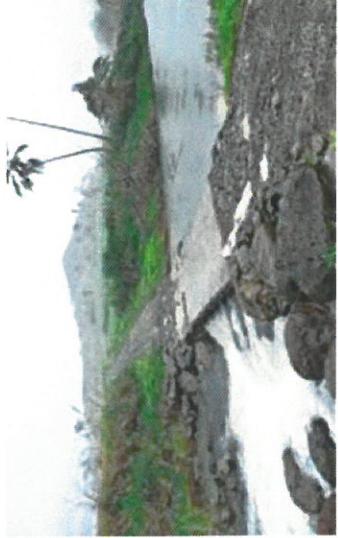
Navakuru Road	Bridge – Low level Crossing Wairiki/Navakuru	0.081km	Status: Approaches on both sides damaged and being continually washed out by flood waters. Deck rebar exposed. Backfill on abutment washed out. Condition of superstructure has surpassed its lifespan. Cracks visible on concrete. Recommendation: Construct new crossing (10m)

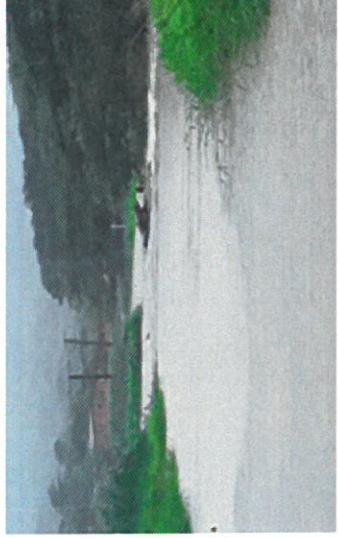
2 – 3 months
Urata Road	Bridge – Low level Crossing Urata	0.173km	Status: Approaches on both sides continually washed by flood waters. Recommendation: Extend approaches both ends to prevent washouts

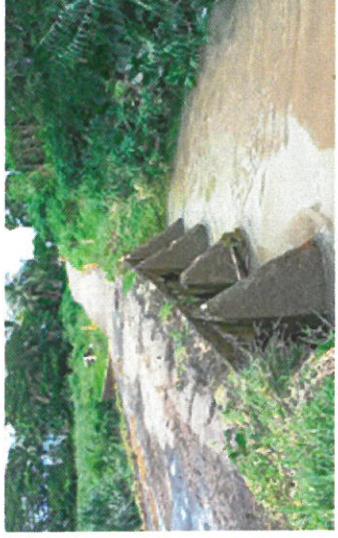
2 weeks
Qawa Road	Bridge – Low level Crossing Qawa	0.068km	Status: Approaches on both sides damaged and being continually washed out by flood waters. Deck rebar exposed. Backfill on abutment washed out. Condition of superstructure has surpassed its lifespan. Cracks visible on concrete. Recommendation: Construct new crossing (15m)

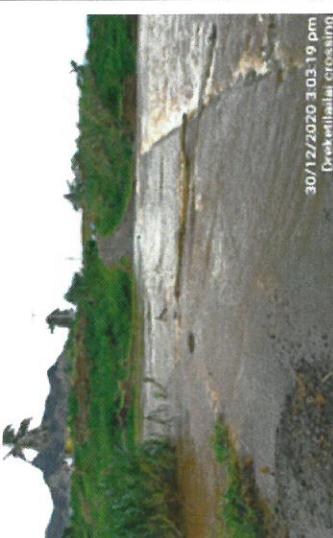
Bulileka Road	Bridge – Low Level Crossing Dreketilailai	8.667km	Status: Approaches on both sides continually washed by flood waters.	Recommendation: Extend approaches both ends to prevent washouts

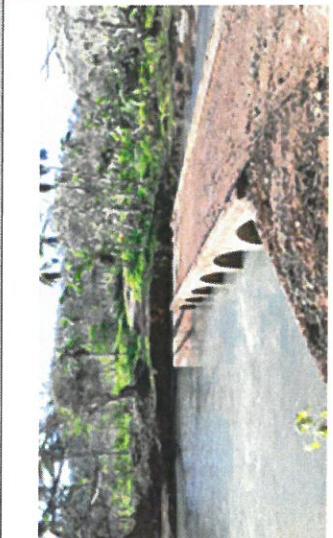
Road Name	Asset Type	Location (km)	Status of Damage/Recommendation	Photo	Cost	Construction Duration
Zone 2 - Natua						
Lutukina Road	Bridge – Low level crossing Lutukina	2.606km	Status: Width of river has extended due to TC Yasa hence approach has been washed out

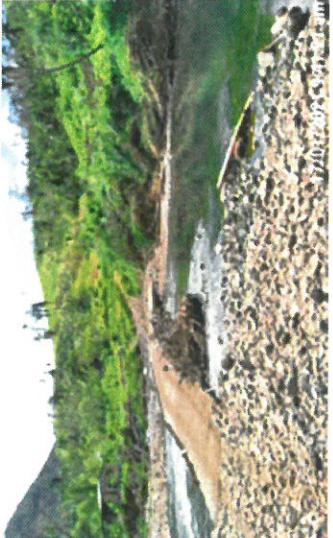
Drawa Village Road	Bridge – Low level crossing Drawa	0.774km	Status: Approaches on both sides damaged and being continually washed out by flood waters. Deck rebar exposed. Backfill on abutment washed out. Condition of superstructure has surpassed its lifespan. Cracks visible on concrete. Recommendation: Construct new crossing (25m)

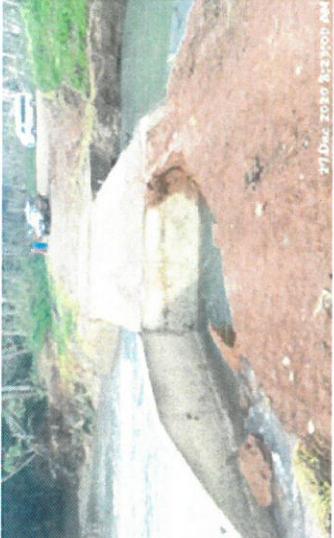
7 months
Narailagi Road	Bridge – Low level crossing Narailagi	1.835km	Status: Width of river has extended due to TC Yasa hence approach has been washed out Recommendation: Crossing to be extended to suit the current river width

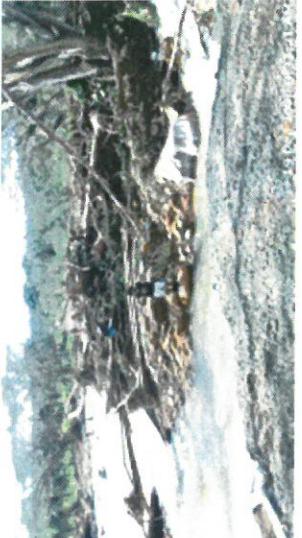
1.5 months
Namuavoivoi Road	Bridge – Low level crossing Namuavoivoi 1	8.528km	Status: Approach washed out and rip rap wall damaged Recommendation: Extend bridge deck and repair rip rap wall

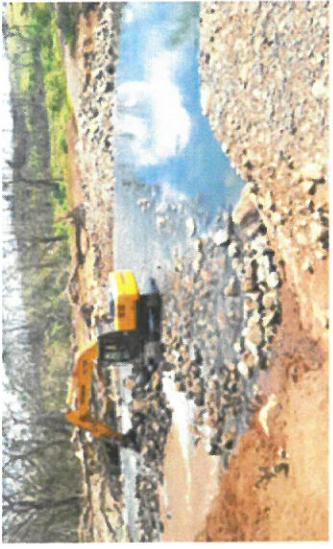
Namuavoivoi Road	Bridge – Low level crossing Namuavoivoi 2	10.504km	Status: Complete Washout of structure Recommendation: Construct new crossing (22m)

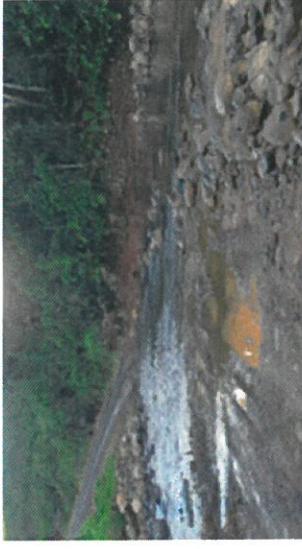
6 months
Namuavoivoi Road	Bridge – Low level crossing Sigawe	13.983km	Status: Current state of crossing is underwater and badly deteriorated. Recommendation: Construct new crossing (20m)

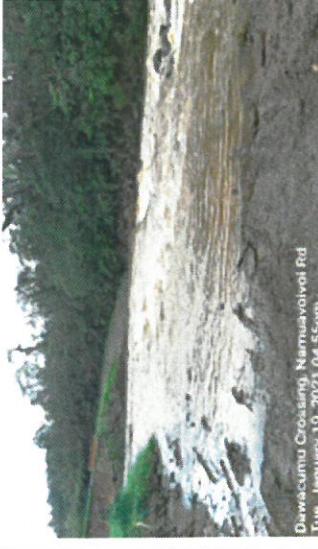
<small>Dawacumu Crossing, Namuavoivoi Rd Tue, January 19, 2021 04:55pm</small>	6 months

6 months
Namuavoivoi Road	Bridge – Low level crossing Dawacumu	24.101km	Status: Approaches on both sides damaged and being continually washed out by flood waters. Deck rebar exposed. Backfill on abutment washed out. Condition of superstructure has surpassed its lifespan. Cracks visible on concrete. Recommendation: Construct new crossing (20m)

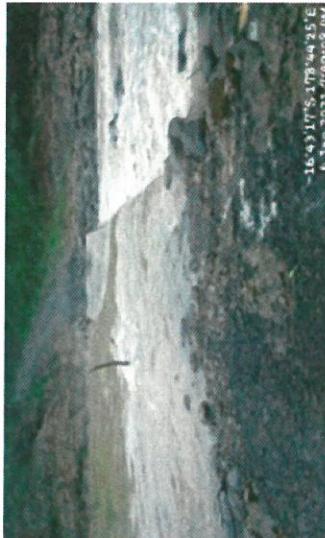
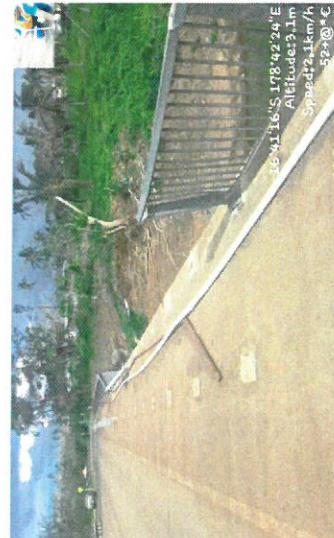
Korokadi Road	Bridge – Low level crossing Banikaea	5.732km	Status: Approaches on both sides damaged and being continually washed out by flood waters. Deck rebar exposed. Backfill on abutment washed out. Condition of superstructure has surpassed its lifespan. Cracks visible on concrete. Recommendation: Construct new crossing (15m)

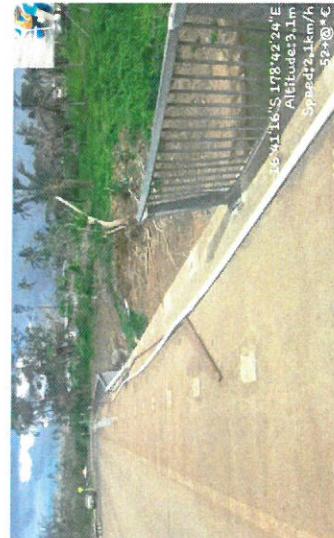
-16.41176,178.42244 Altitude: 23.1m Speed: 42.1km/h 52° @ -2°C 15 Jan 2022 17:05:56 PM	4 – 5 months
Nabouwalu Road	Bridge Nakadrudru	93.547km	Status: Damage to railings and guard rails Recommendation: Fabrication and installation of damaged sections

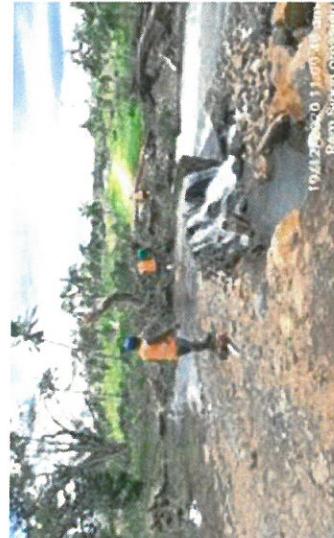
-16.41176,178.42244 Altitude: 23.1m Speed: 42.1km/h 52° @ -2°C 15 Jan 2022 17:05:56 PM	2 weeks
Nabouwalu Road	Bridge - Low level crossing Ram Singh	163.07km	Status: Approaches on both sides continually washed by flood waters. Deck rebar exposed. Backfill on abutment washed out. Condition of superstructure has surpassed its lifespan. Cracks visible on concrete. Recommendation: New crossing construction (12m)

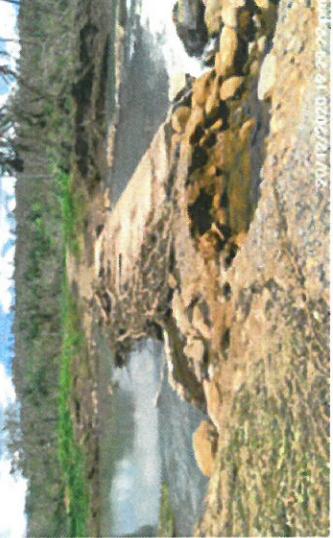
Nabouwalu Road	Bridge - Low level crossing Korolevu	166.80km	Status: Approaches on both sides continually washed by flood waters. Deck rebar exposed. Backfill on abutment washed out. Condition of superstructure has surpassed its lifespan. Cracks visible on concrete.

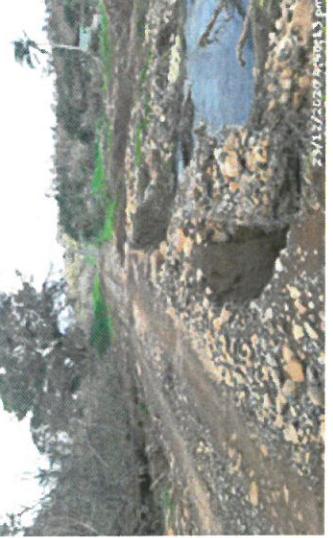
7 months
Nabouwalu Road	Bridge - Low level crossing Saolo	169.97km	Status: Approaches on both sides continually washed by flood waters. Deck rebar exposed. Backfill on abutment washed out. Condition of superstructure has surpassed its lifespan. Cracks visible on concrete.

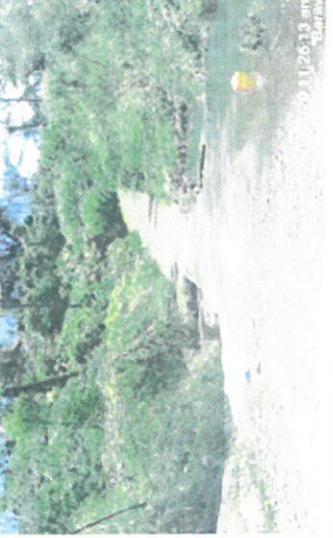
3 – 4 months
Nabouwalu Road	Bridge - Low level crossing Nasawana	160.05km	Status: Approaches on both sides continually washed by flood waters. Recommendation: Extend approaches both ends to prevent washouts

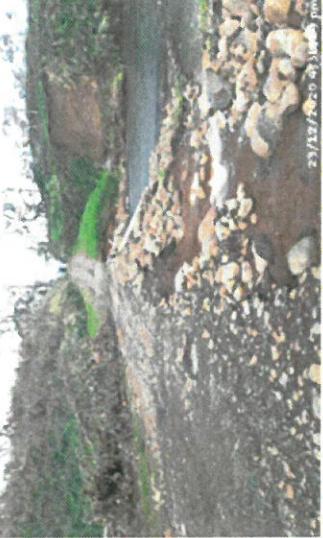
Nabouwalu Road	Bridge - Low level crossing Nakawakawa	171.05km	Status: Approaches on both sides continually washed by flood waters. Deck rebar exposed. Backfill on abutment washed out. Condition of superstructure has surpassed its lifespan. Cracks visible on concrete.

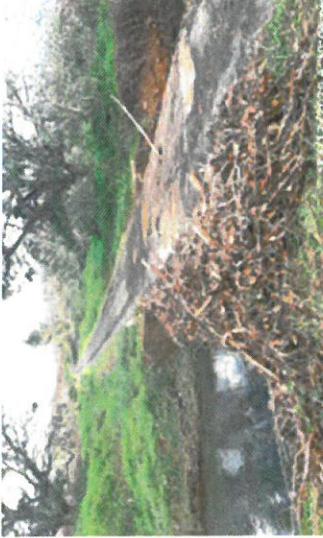
6 months
Nabouwalu Road	Bridge - Low level crossing Nabunikadamu	172.03km	Status: Approaches on both sides continually washed by flood waters. Deck rebar exposed. Backfill on abutment washed out. Condition of superstructure has surpassed its lifespan. Cracks visible on concrete.

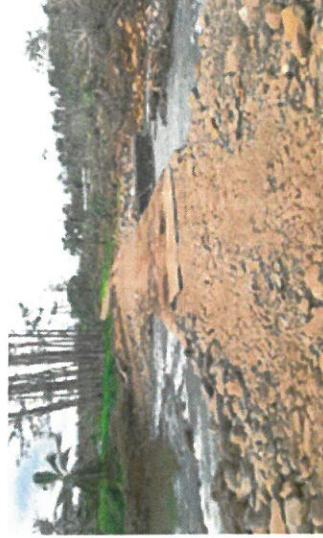
3 – 4 months
Nabouwalu Road	Bridge - Low level crossing Daria Bridge	176.51km	Status: Approaches on both sides continually washed by flood waters. Deck rebar exposed. Backfill on abutment washed out. Condition of superstructure has surpassed its lifespan. Cracks visible on concrete.

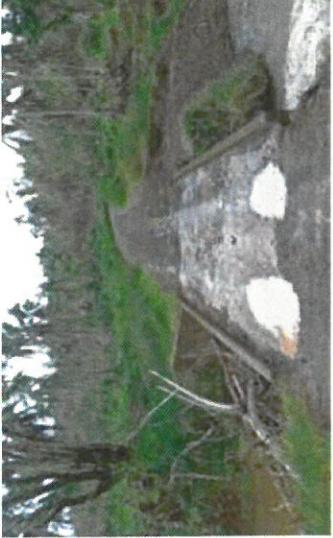
Kubulau Road	Bridge - Low level crossing Kilaka Bridge	33.88km	Status: Approaches on both sides continually washed by flood waters. Recommendation: Extend approaches both ends to prevent washouts

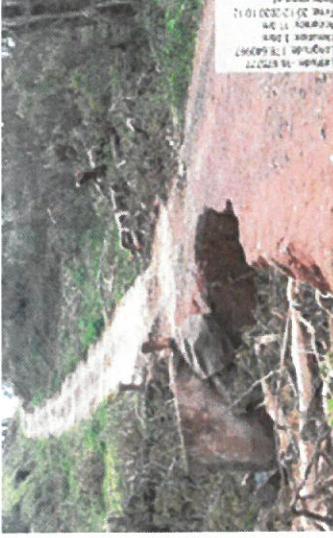
2 weeks
Naviqiri Road	Bridge - Low level crossing	7.518km	Status: Abutment backfilled washout with underslip scouring Recommendation: Extend approaches both ends to prevent washouts and rip rap protection

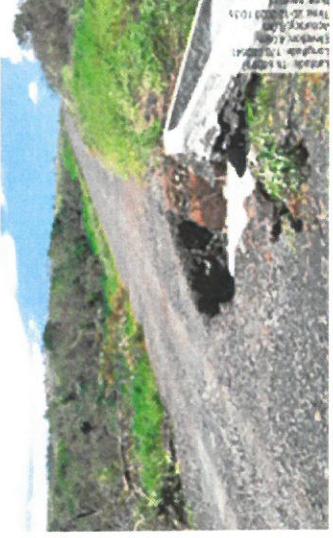
2 weeks
Naviqiri Road	Culvert Washout	3.497km	Status: Abutment backfilled washout with underslip scouring Recommendation: Extend approaches both ends to prevent washouts and rip rap protection
